Battery Reinitialization of the Photovoltaic Module of the International Space Station

Gyan Hajela and Fred Cohen
The Boeing Company, Canoga Park, California

Prepared for the
37th Intersociety Energy Conversion Engineering Conference
sponsored by the Institute of Electrical and Electronics Engineers,
Electron Devices Society
Washington, DC, July 28–August 2, 2002

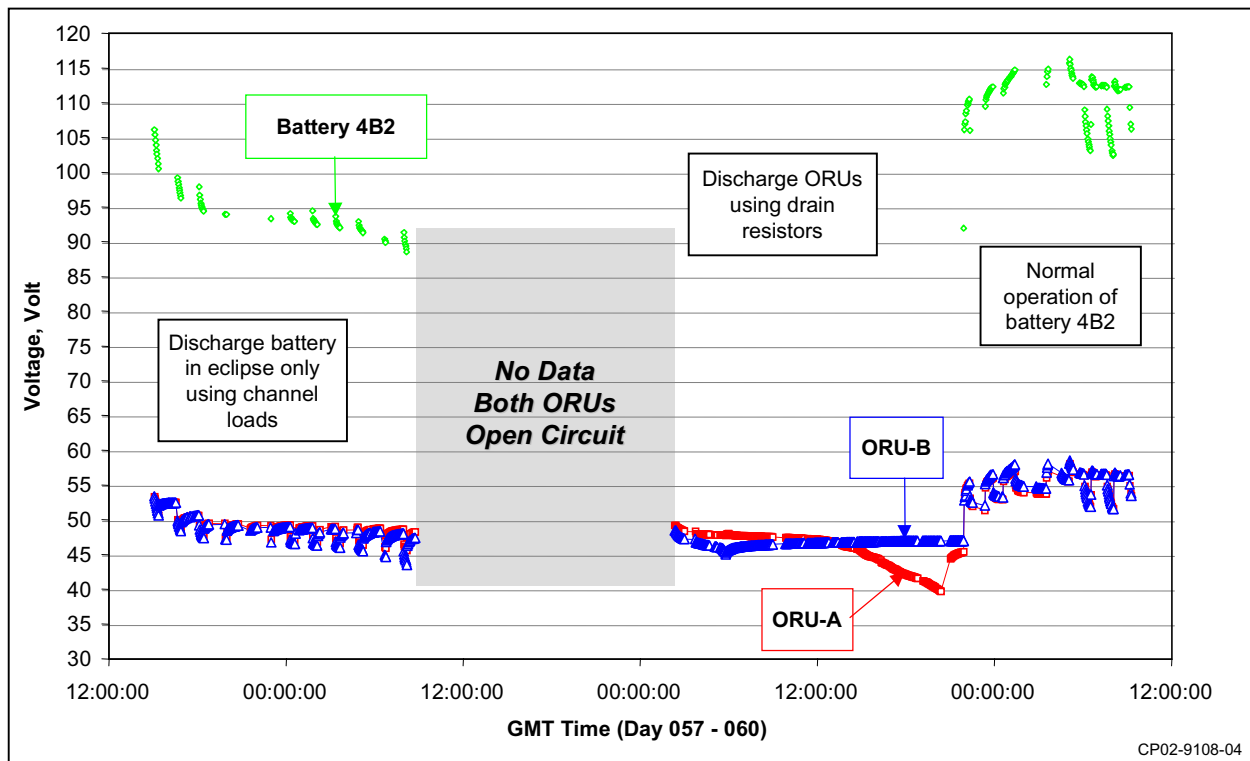
FIGURE 4. 4B2 VOLTAGES VS. TIME

- Figure 4 shows that the battery voltage remained well above the cutoff value of 76 V.
 - Figure 5 shows that cells of ORU 4B2A and 4B2B remained tightly grouped together, as before. Average pressure of ORU 4B2A and 4B2B remained apart by about the same value during this step, that is, no change in the ORU pressure differential.

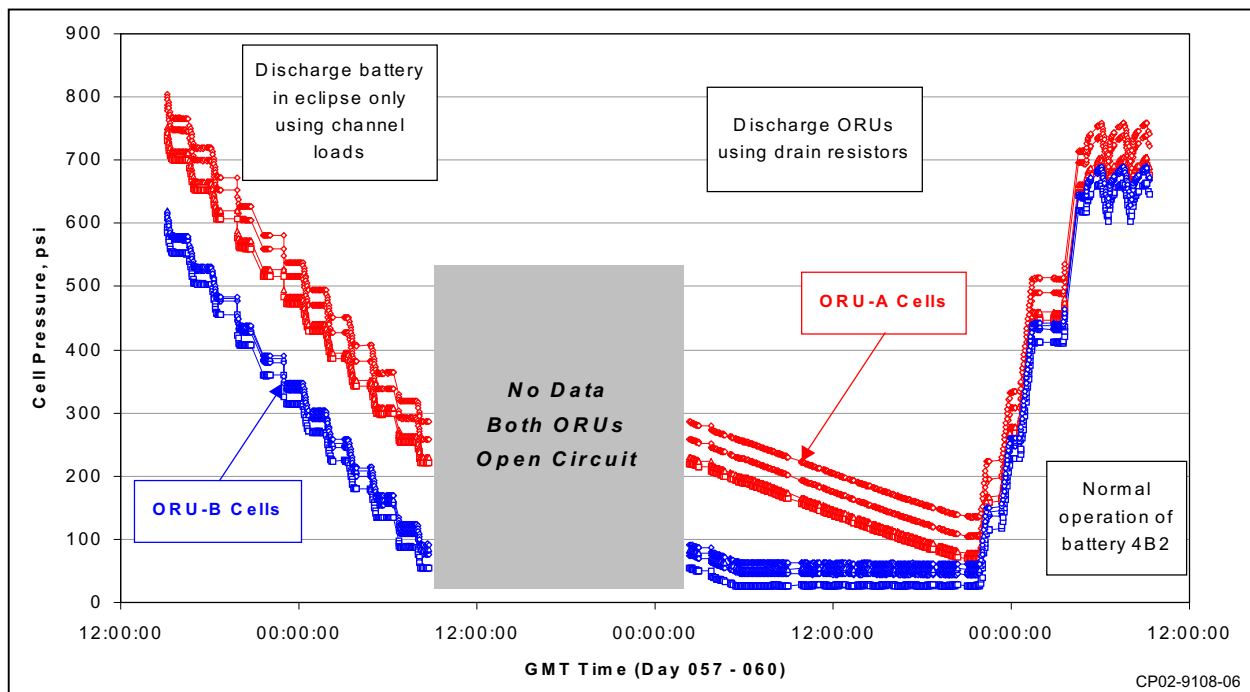
FIGURE 5. MONITORED CELL PRESSURES

- Figure 5 shows cell pressures. It can be seen that cells of ORU 4B2A and 4B2B remained tightly grouped together. Cell pressures dropped steadily during the eclipse periods and stayed unchanged during the insolation periods (charge inhibited). Average pressure of ORU 4B2A and 4B2B remained apart by about the same value during the discharge.

- Figure 5 shows that cells of ORU 4B2A and 4B2B remained tightly grouped together, as before. Pressure of cells in ORU 4B2A dropped during this step while pressure of cells in ORU 4B2B stayed the same. ORU pressure differential, at the time when ORU 4B2A reached the cell cutoff voltage, was reduced to 50 psi.
